Stream Inventory Report

San Jose Creek

2006

Prepared by: Jennifer Nelson (California Department of Fish and Game)
Eileen Baglivio and Tim Kahles (California Conservation Corps)

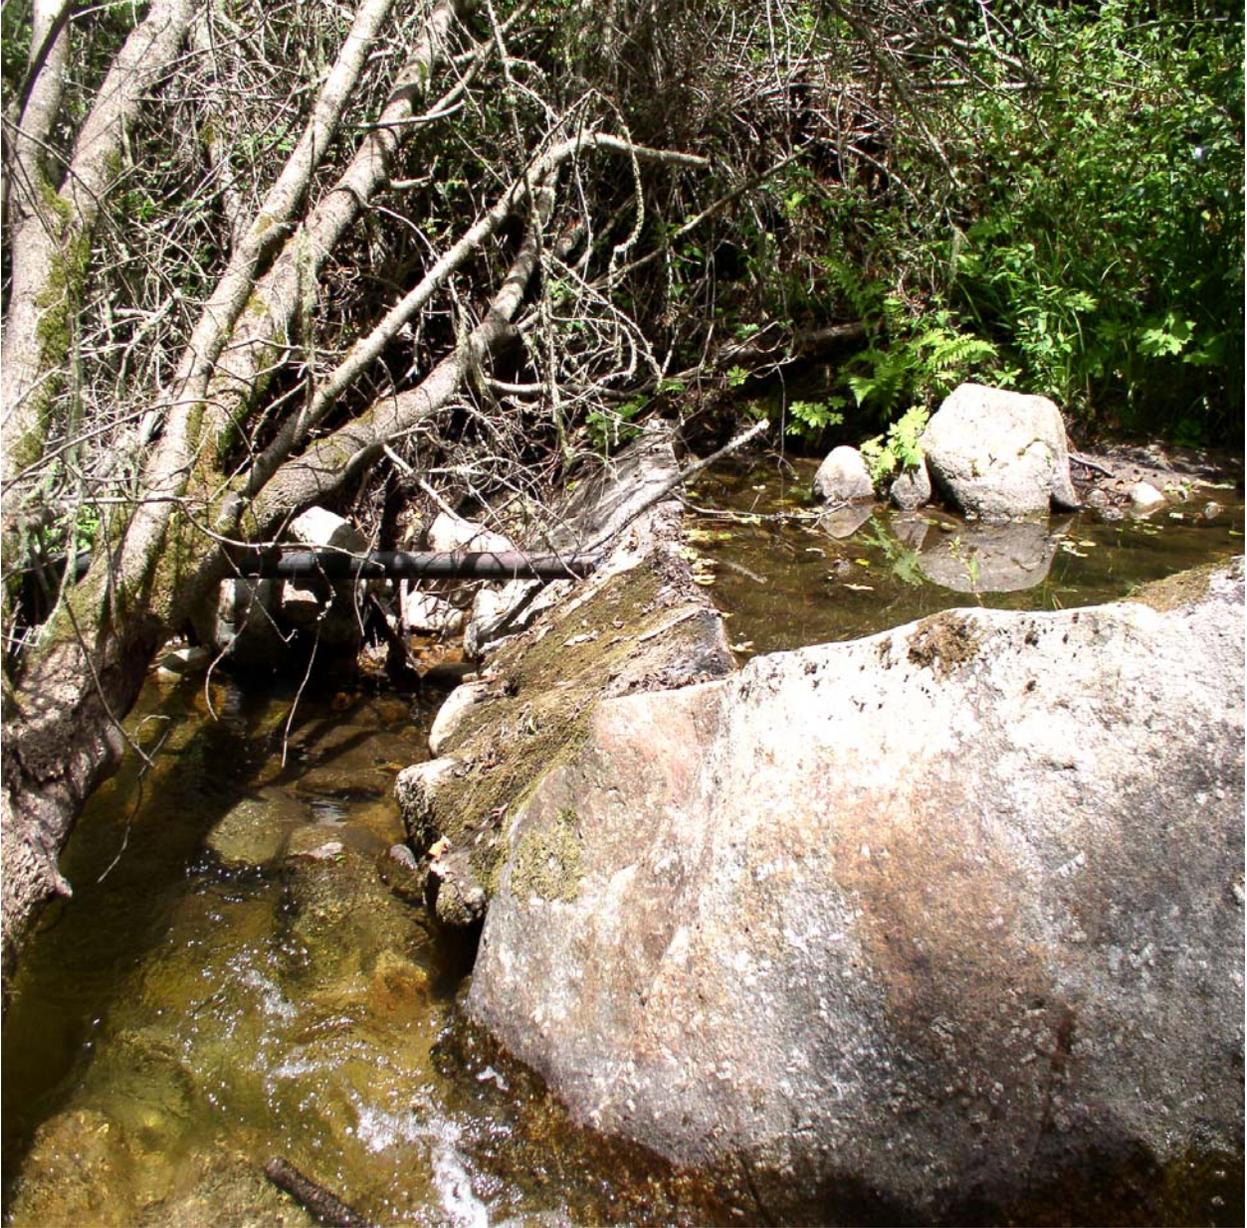
One concrete dam and one concrete weir, located in habitat units 156/157 and 748 respectively, were noted during the survey. The dam in unit 156 extends 12 feet into the creek channel from the right bank and is 3.5 feet high with the face of the dam sloped back at a 45 degree angle. Upstream of the dam, the creek channel has aggraded three feet. Fish passage on the left bank side is unaffected (Figure 9).

Figure 9. Concrete dam in units 156 and 157, San Jose Creek, 2006.

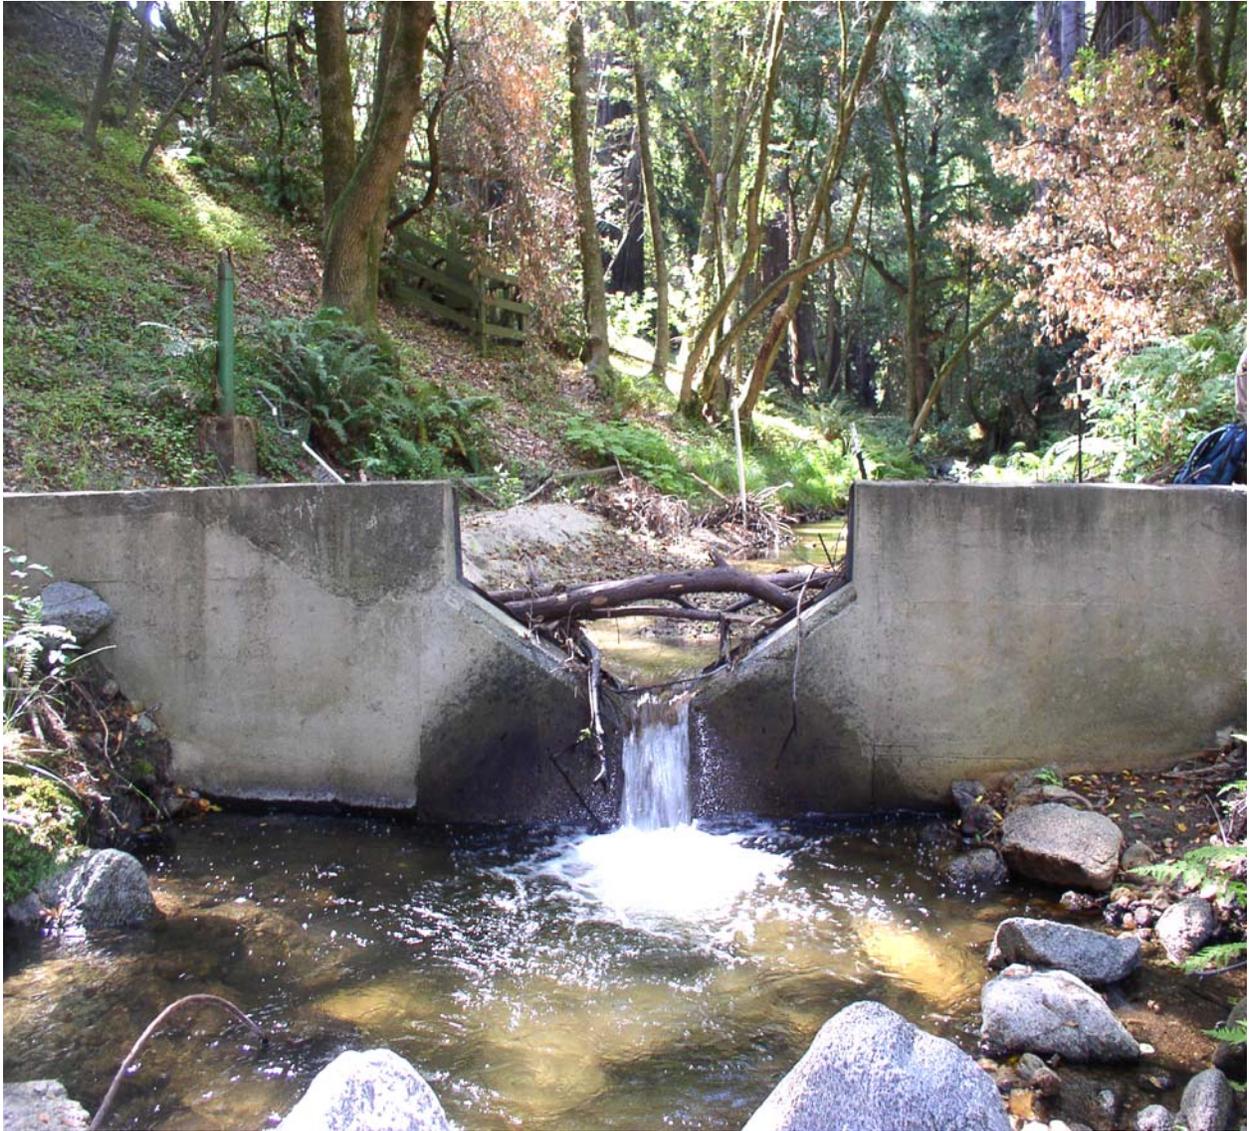
In unit 748, a concrete weir spans the 36 foot wide creek channel. The structure has a V-shaped notch that ranges from 7 feet wide at the top to 0.9 feet wide at the bottom. The jump from the stream up to the notch is a 2.1 feet high and the pool below is 2.2 feet deep. Upstream, the channel has aggraded 1.8 feet. The structure is being undermined on the left bank side (Figure 10).

Figure 10. The concrete weir/ flashboard dam in unit 748, San Jose Creek, 2006.
