# STREAM INVENTORY REPORT

## SENECA CREEK

Prepared by:  
Jennifer Nelson, DFG  
Assisted by:  
Eileen Baglivio and Tim Kahles,  
CA Conservation Corps  
**2006**

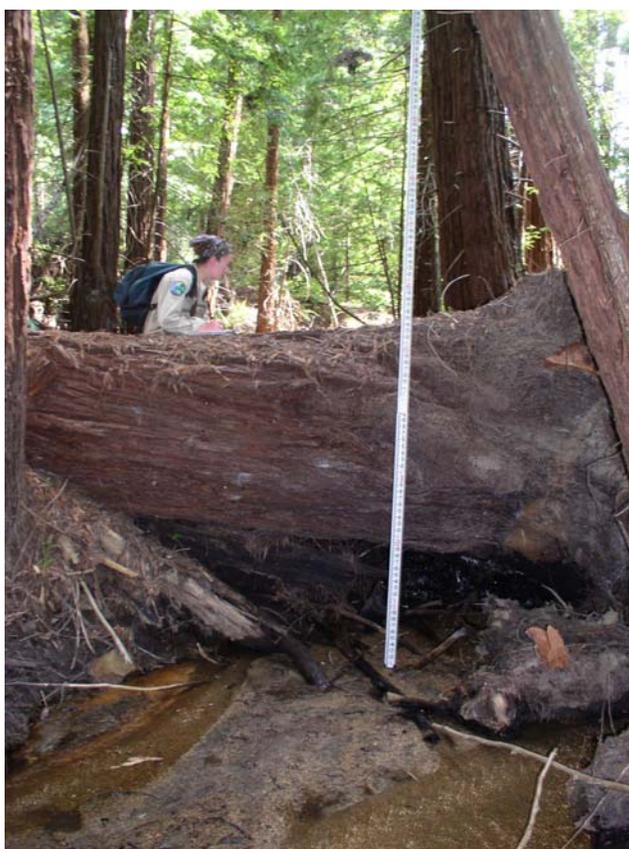
In addition to the bedrock sheets, there were also multiple log jams. Approximately 50 log jams (composed of small and/or large woody debris) were identified within the surveyed reach, the majority of which would not impede fish passage or become barriers to upstream migration. In most cases the jams were slightly aggraded with flow through sediment or woody debris. There were also some instances of head cutting that created a log jam, and jams that were considered “floaters” with flow under jam. Three log jams that have the potential to become impediments or barriers are located in habitat units 271, 321, and 414. The unit 321 jam, located at stream mile 1.5, was a 5.5 foot jump over a downed redwood. There is an overflow channel around the downed tree on the LB side. Refer to figure 2.

Figure 2. Problematic log jam, unit 321, Seneca Creek, 2006.

- 4) The three significant log jams that were mentioned under the potential impediment section should be surveyed every other summer to determine if adult salmonids are still able to pass upstream. If not, and the log jams are not serving the purpose of stabilizing a slide, then CDFG should be contacted for possible modification of the sites.

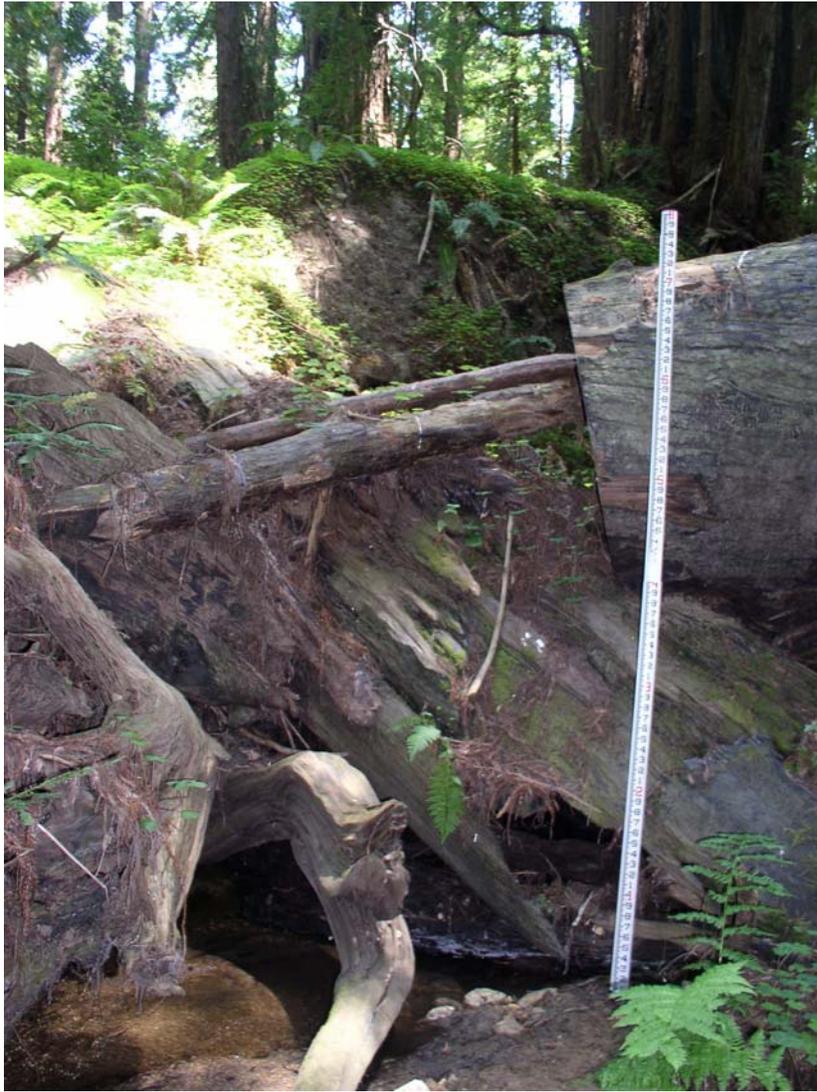
There was a jam at unit 414, stream mile 1.9. This jam includes downed large woody debris off of the right bank and bucked up wood in the channel creating a 5-7 foot high barrier. Refer to figure 3.

Figure 3. Problematic log jam, unit 414, Seneca Creek, 2006.

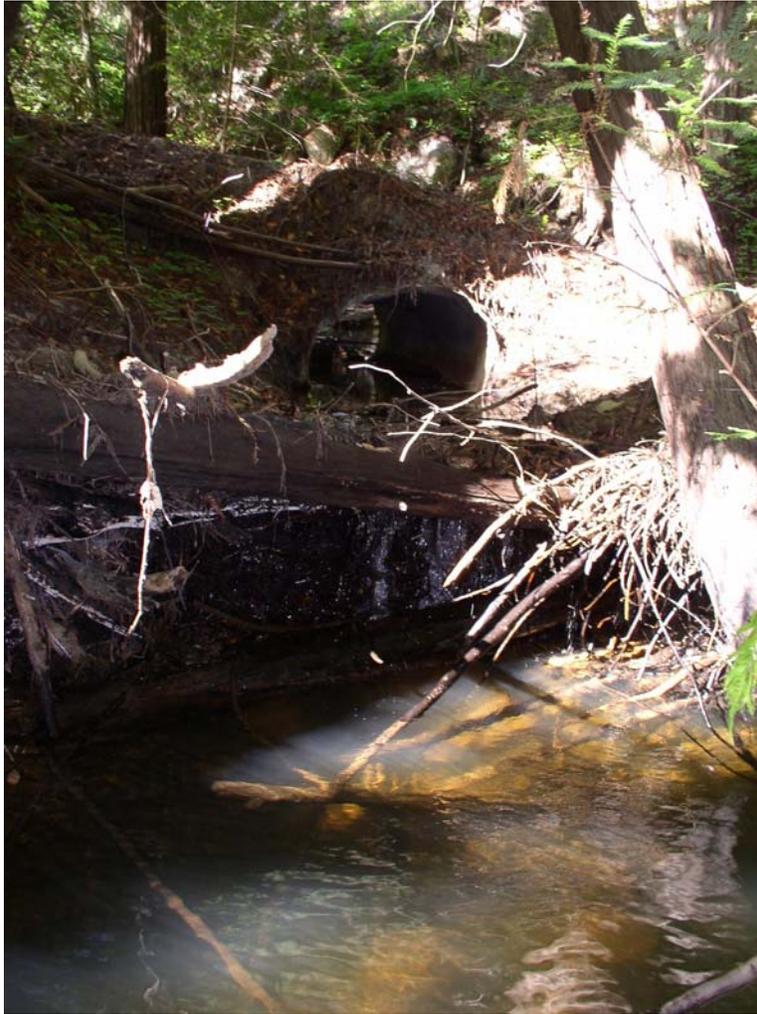
There is a road that follows Seneca Creek in close proximity for most of the survey. The creek flows under the road in three locations through metal culverts (units 235, 237, and 296). Two of these are potential impediments at the time of survey. In unit 235 (stream mile 1.1), there is a **squashed** culvert that is 39 inches in diameter. The main channel makes a right turn into the culvert, eroding the left bank. The flow on the upstream side is partially under the culvert. Below the culvert, there is a pool with a 2.5ft jump over woody debris that is aggraded 4 feet. Refer to figure 4.

Figure 4. Culvert in unit 235, Seneca Creek, 2006

- 5) Six road crossings were located within the survey reach. Three of these crossings included culverts under the road. If the road crossings are not used they should be graded and revegetated. If they are used, they should be rocked to the top of the slope or some other way stabilized to prevent sediment from entering during rain events.

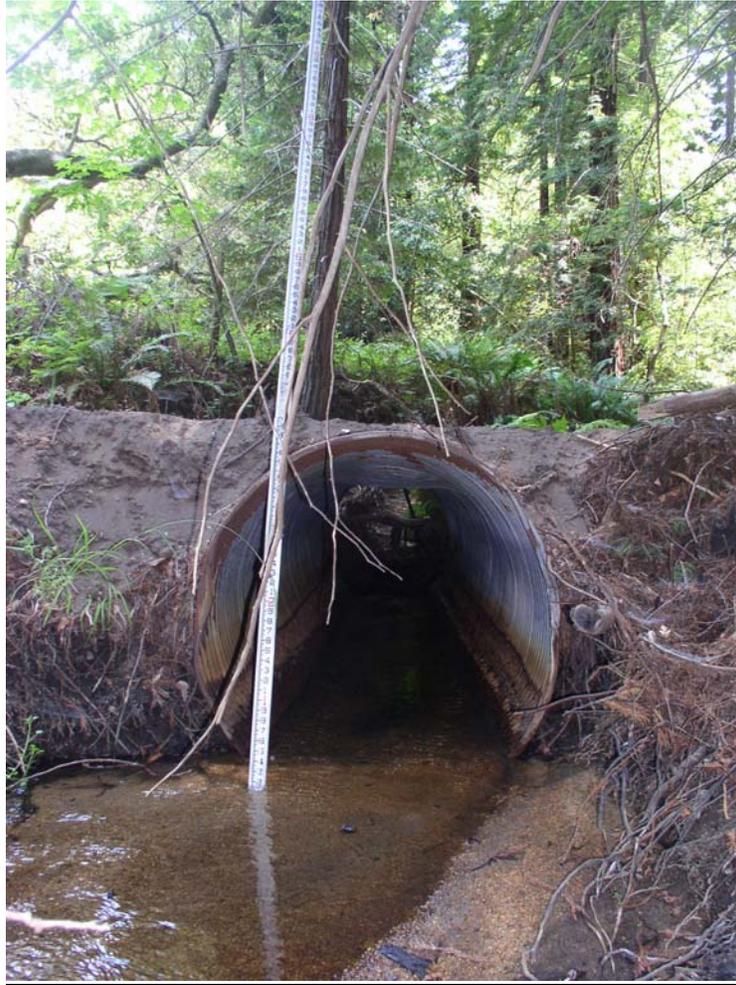
The second culvert that may be an impediment is located in unit 296 at stream mile 1.4. This culvert is 20 feet long and the road prism above is only 14 feet wide, the culvert ends are exposed. **Culvert dimension in notes.** There is a woody debris pile on the upstream side of the culvert due to no debris rack. The culvert has no gradient, making adult steelhead migration problematic. On the road above the culvert, there are 1 to 2 foot high sidecast dirt piles with the potential to add large quantities of soft sediment to the creek. Refer to figure 5.

Figure 5. Culvert in unit 296, Seneca Creek, 2006

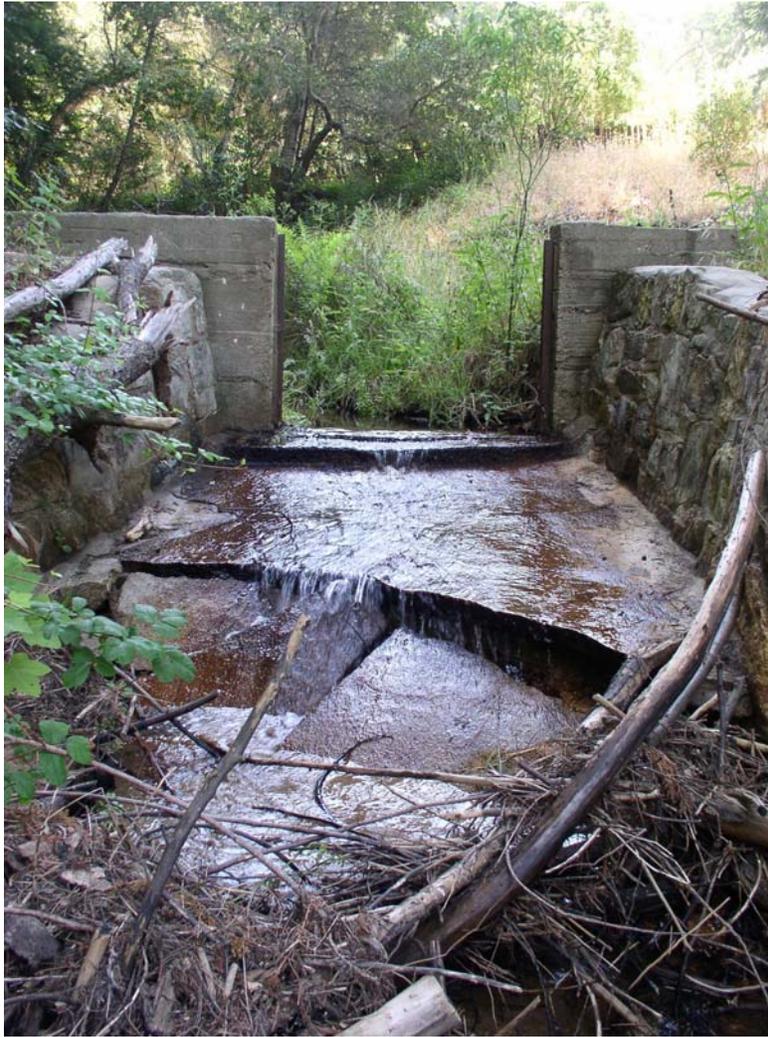
Another possible impediment to upstream fish migration is the defunct flash board dam and concrete apron located at unit 377 (stream mile 1.7). The lower 4 feet of the concrete apron is broken into slabs with an additional 7 foot piece connected to the dam. The apron has a gradient increase of 3 percent. At the top of the apron, there is a 4 inch high concrete jump onto a concrete bar that is 2 feet wide. The concrete flashboard abutments are 4.2 feet high; the right abutment is 8 feet long and the left one is 10.5 feet wide. Fish passage could be possible with more flow. Refer to figure 6.

Figure 6. Concrete flashboard dam, unit 377, Seneca Creek, 2006.

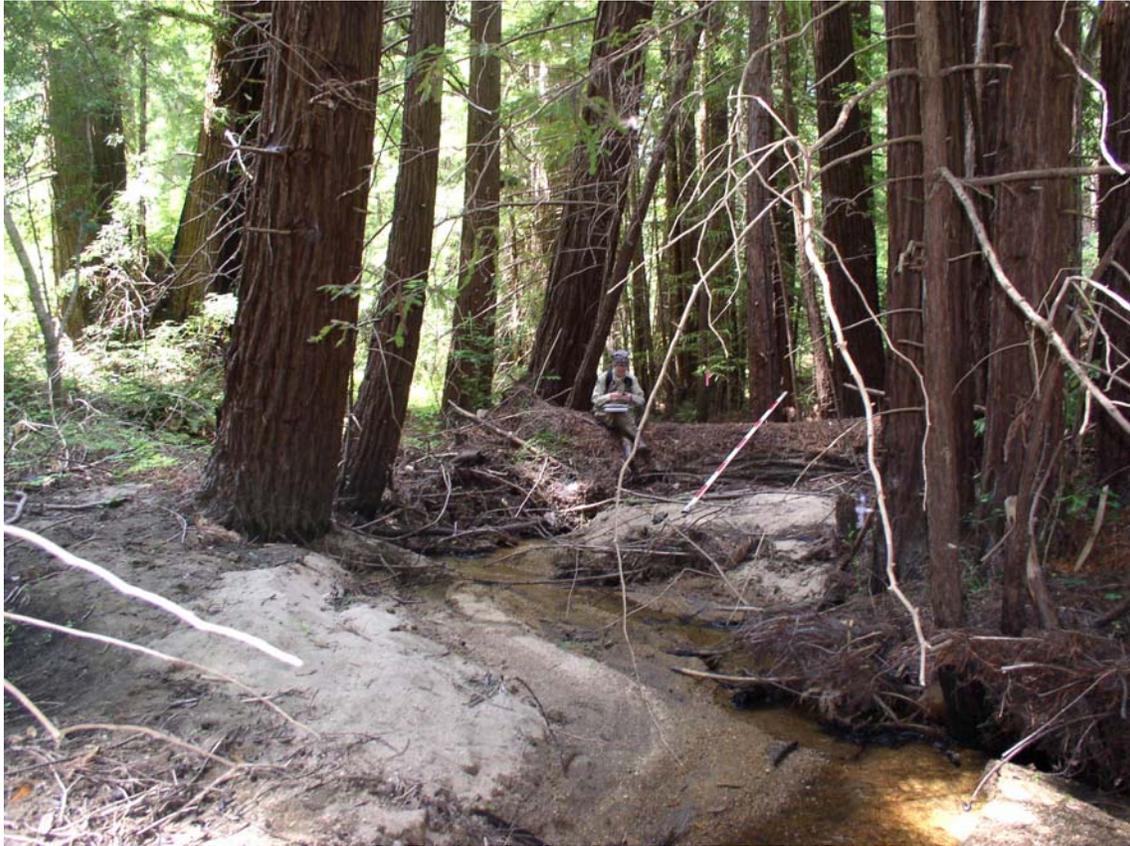
Throughout Seneca Creek, there were a few areas with bank erosion adding sediment to the creek. Only one of these denuded sections was significant, having a length of over 50 feet. The erosion mentioned in unit 311 consisted of two sections of denuded banks. The first section was 12 feet high by 20 feet long and appeared to be slide material. The upper area was a 15 feet high by 100 feet long sediment wall. In addition to the denuded banks, the creek had a couple of other distinguishing characteristics. These include channels with large deposits of sand and decomposed granite on the banks and in the creek. Refer to figure 7. The other feature was exceedingly sinuous channels in certain areas. These factors may be due to heavy geological activity.

Figure 7. Meandering channels with sand deposits along banks, Seneca Creek, 2006.

- 7) Bank revetment may be worthwhile in those locations that are not eroding due to large scale land movement. Most banks will revegetate quickly on their own, but if banks are identified that actively eroding or wasting and are adding large quantities of sediment to the channel every year, some type of revetment may be warranted.
