# STREAM INVENTORY REPORT

## SENECA CREEK

Prepared by:  
Jennifer Nelson, DFG  
Assisted by:  
Eileen Baglivio and Tim Kahles,  
CA Conservation Corps  
**2006**

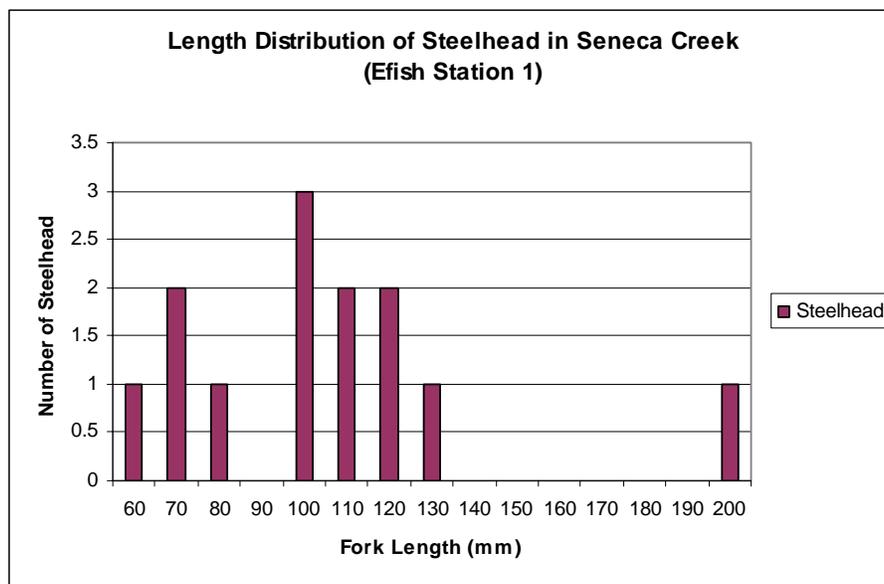
At station one, 13 steelhead were captured with a calculated abundance of 13 steelhead. Because of the paucity of age/length data for steelhead in the central coast region, somewhat arbitrary size-breaks were used to delineate age classes. Because of the time of year the sampling was done, steelhead less than 90 millimeters in fork length are considered to be young-of-the-year or age 0+ fish; fish between 91 to 165 millimeters are considered to be age 1+; and fish between 166 and 250 millimeters are in the category of age 2+. Using this criteria, 4 of the steelhead captured were considered to be age 0+ with an average fork length of 74mm (range: 68-87mm), 8 of the steelhead captured were 1+ with an average fork length of 116mm (range: 103-134), and 1 of the steelhead was age 2+ with a fork length of 205mm.

Graph 12. Length frequency distribution of steelhead captured in Seneca Creek, October 2006.
